Determination of Effect on Essential Fish Habitat from the Phase V Early Restoration, Florida Coastal Access Project

2.0 Florida Coastal Access Project Description

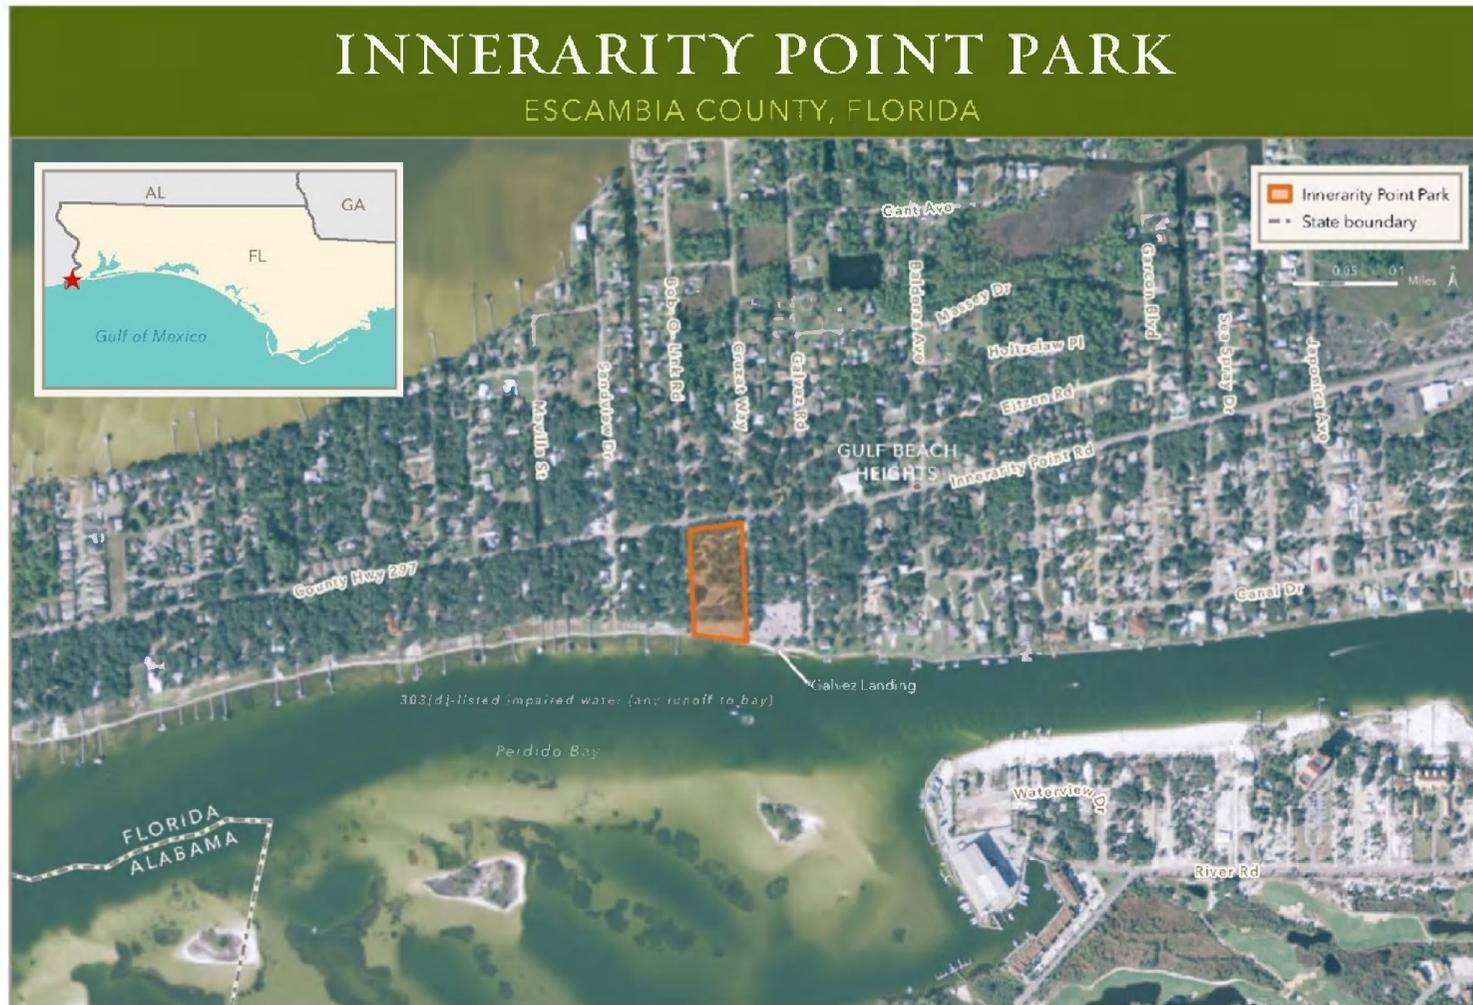
Figure 1: Proposed Innerarity Point Park Plot; 3.38 acre site in Escambia County, Florida on Perdido Bay.

The proposed Innerarity Point Park component is located in Escambia County (see Figure 1 for proposed parcel location) and is adjacent to the heavily-used Galvez Landing boat ramp (which was improved as part of Phase I Early Restoration (see Section 4.7 of the Phase I Early Restoration Plan and Environmental Assessment (Phase I ERP/EA))). The 3.38-acre site for the proposed Innerarity Point Park includes 265 linear feet of frontage along the Old River, a heavily used waterway for recreational vessel traffic, which flows between Innerarity Point and Perdido Key out to Perdido Bay (see Figure 2, Figure 3, and Figure 4). An unoccupied single family house (constructed in 2004) and gravel driveway occupies the northern portion of the property. A second residential structure previously existed at the southern portion of the property overlooking the Old River waterway. Although the second residential structure no longer exists, the concrete foundation remains. The remainder of the property is unimproved and consists of lawn area with mature live oaks (see Figure 2), and coastal vegetation along the shoreline (see Figure 2 and Figure 3 for photographs of shoreline).

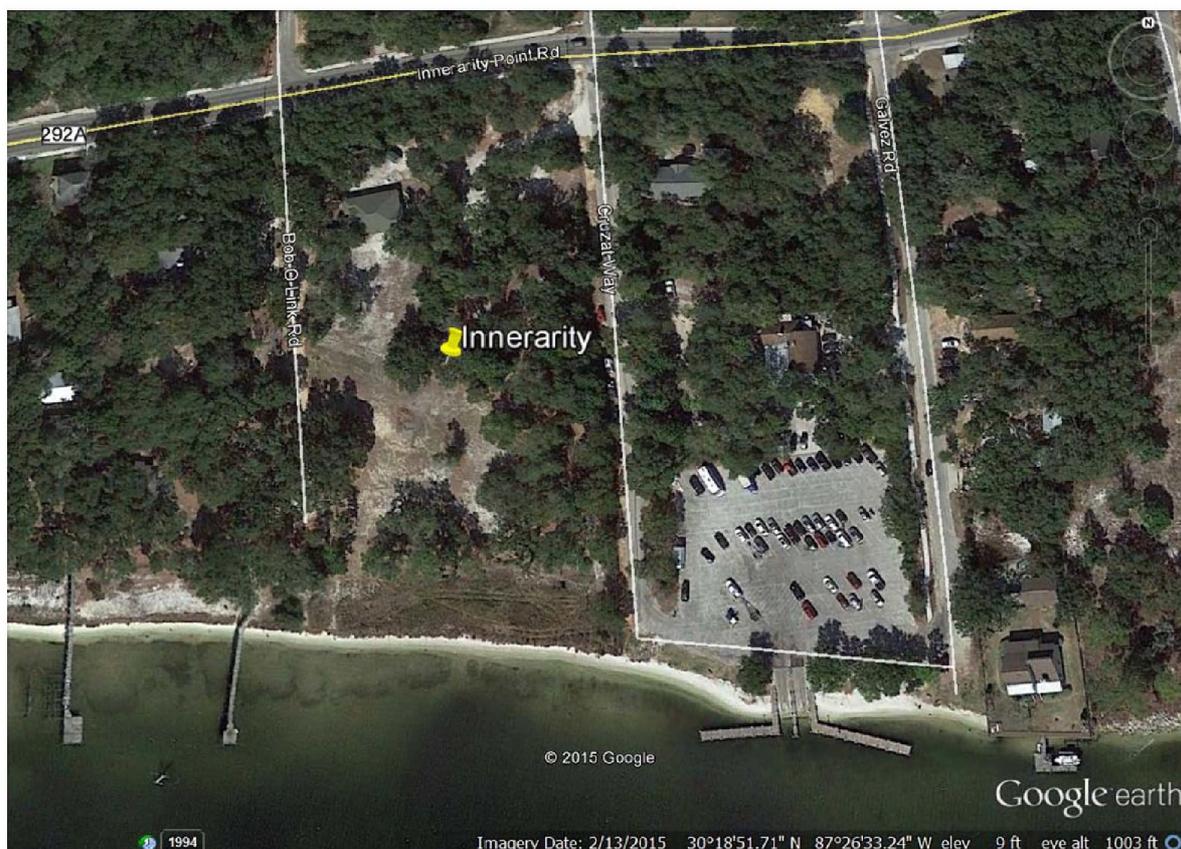
Figure 4: Aerial View of the Proposed Innerarity Point Park Site and Aquatic Habitat (Google Imagery, 2015).

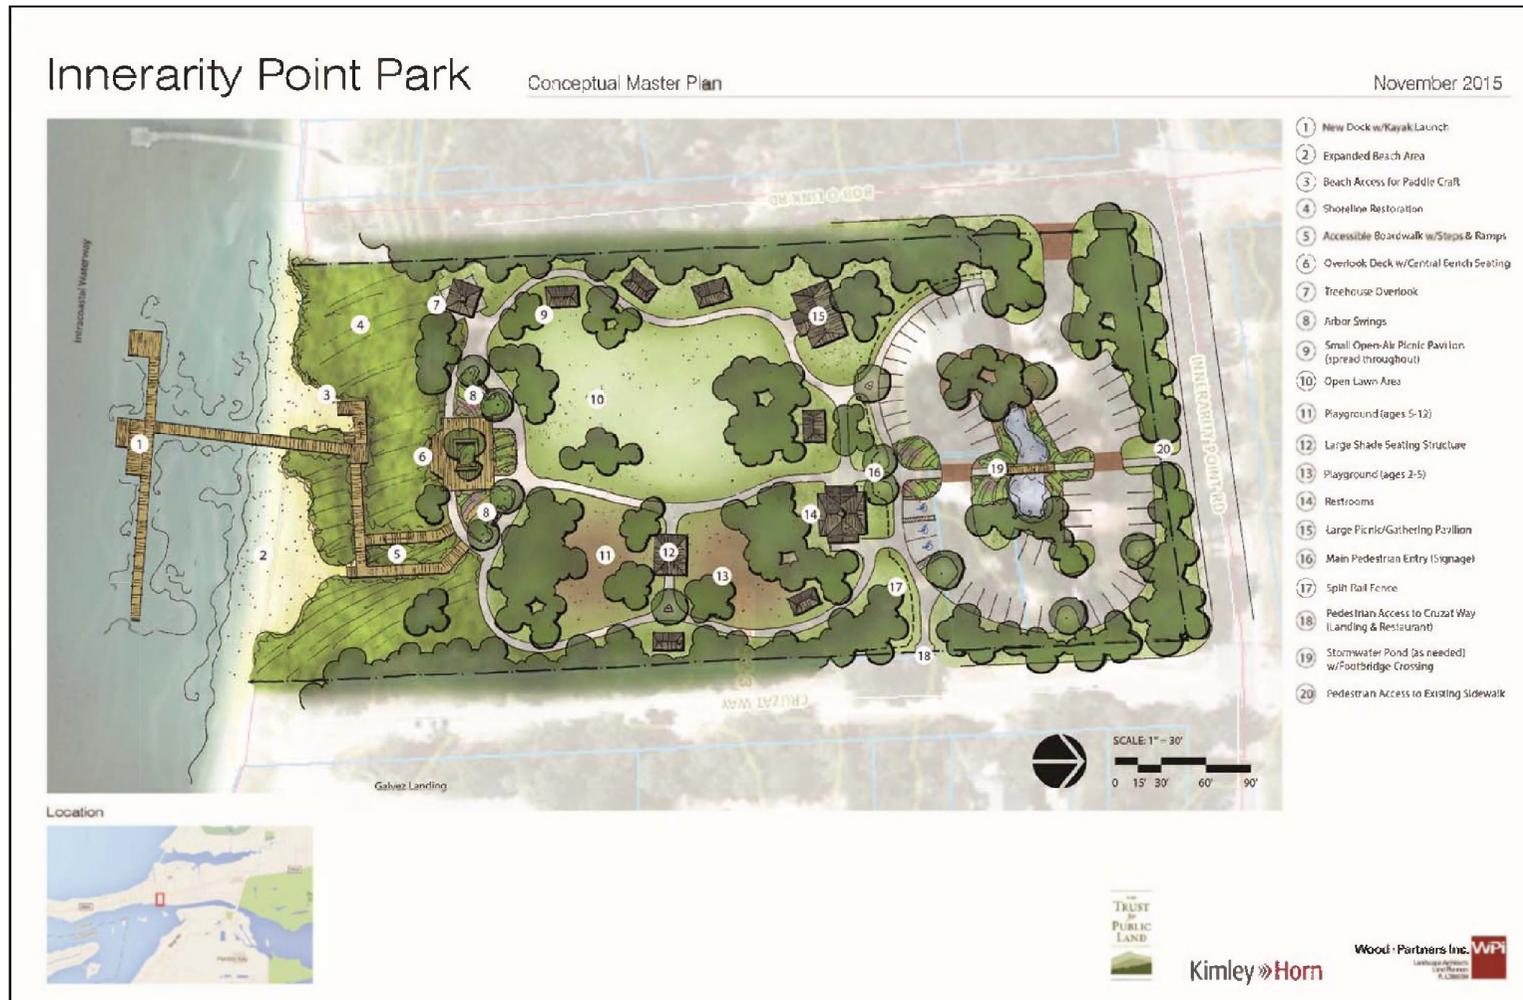
Figure 5: Proposed Innerarity Point Park Conceptual Plan. Left side of the conceptual plan shows the proposed dock.

Specific elements of the proposed Innerarity Point Park conceptual site plan (Figure 5) include the following:

direction. A perpendicular section of pier is proposed at the end of the main branch, and would be oriented approximately east to west and would be constructed in an area devoid of SAV. If necessary, the design of the dock would incorporate the use of composite grated materials that would allow light through to avoid shading impacts to surrounding SAV, and as noted above, would refer to the USACE and NMFS dock construction guidelines.

The proposed work includes constructing a new dock and kayak launch. The main branch of the dock would be oriented approximately north to south and built out through an area devoid of SAV to avoid SAV impacts. The perpendicular dock would be oriented approximately east to west and would be constructed in area devoid of SAV to avoid impacts. However, if it is determined shading impacts may occur, the design of the dock would incorporate the use of composite grated materials that would allow light through to minimize impacts to surrounding SAV. The proposed construction may cause disturbances to EFH from increased suspended sediment and runoff. However, these disturbances are expected to be short-term and minor, and the risks and potential impacts will be minimized by following identified best management practices during implementation.

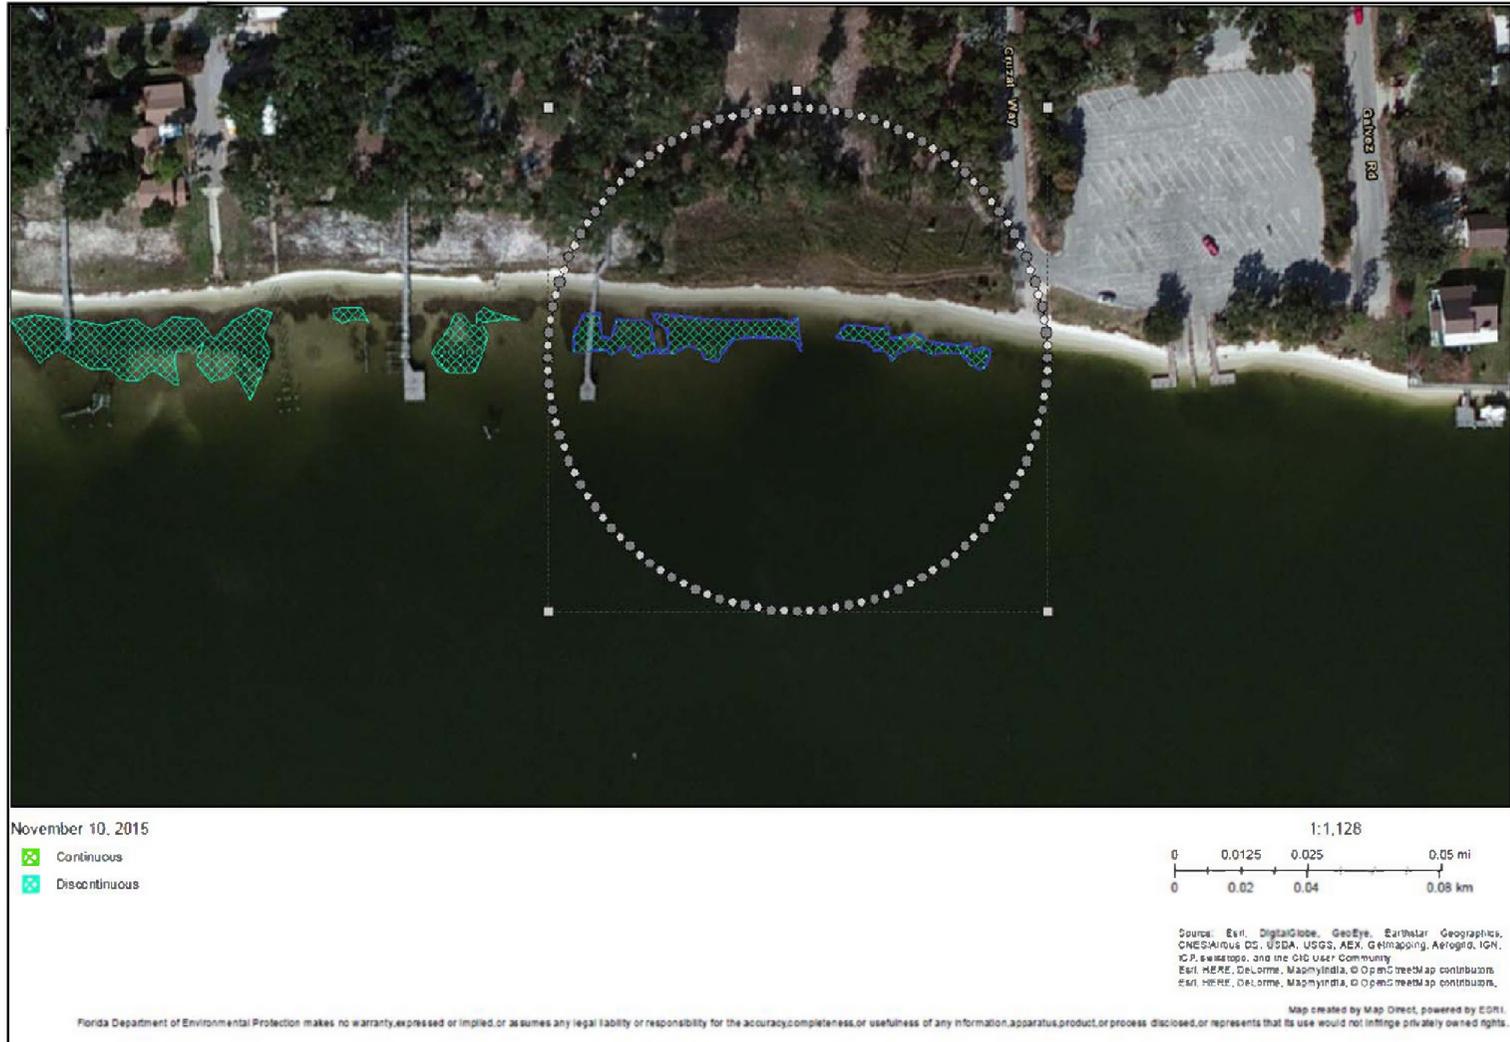
Figure 6: SAV off of the Proposed Innerarity Point Park Parcel (FLDEP 2015).

Note: only part of the area within the circle is off of the proposed Innerarity Point Park site.

The proposed Innerarity Point Park is within the EFH area for coastal migratory pelagics, red drum, reef fish, shrimp, and stone crab. There may be SAV at the Innerarity Point Park location. Based on the Florida Department of Environmental Protection's seagrass GIS data, there appear to be two patches of discontinuous SAV off the proposed site; the western and eastern patches are approximately 0.13 and 0.09 acre in size, respectively (FDEP 2015, see Figure 6). Updated submerged SAV surveys would occur prior to construction (ideally during June 1 through September 30) because SAV bed continuity, extent, and density are subject to change over time. Mud substrate and estuarine water column habitat also exists within the project area. No Habitat Areas of Particular Concern (HAPC) or EFH areas protected from fishing were identified within the project area.

- The dock access walkway would be adjusted to be constructed in between the two existing patches of SAV (Figure 6 and 7).
 - After completion of the SAV survey, the dock would be extended out past the deepest extent of the SAV (approximately greater than 70 feet from shore) to avoid constructing the perpendicular dock directly in the potential SAV beds and avoid the shading of the SAV.

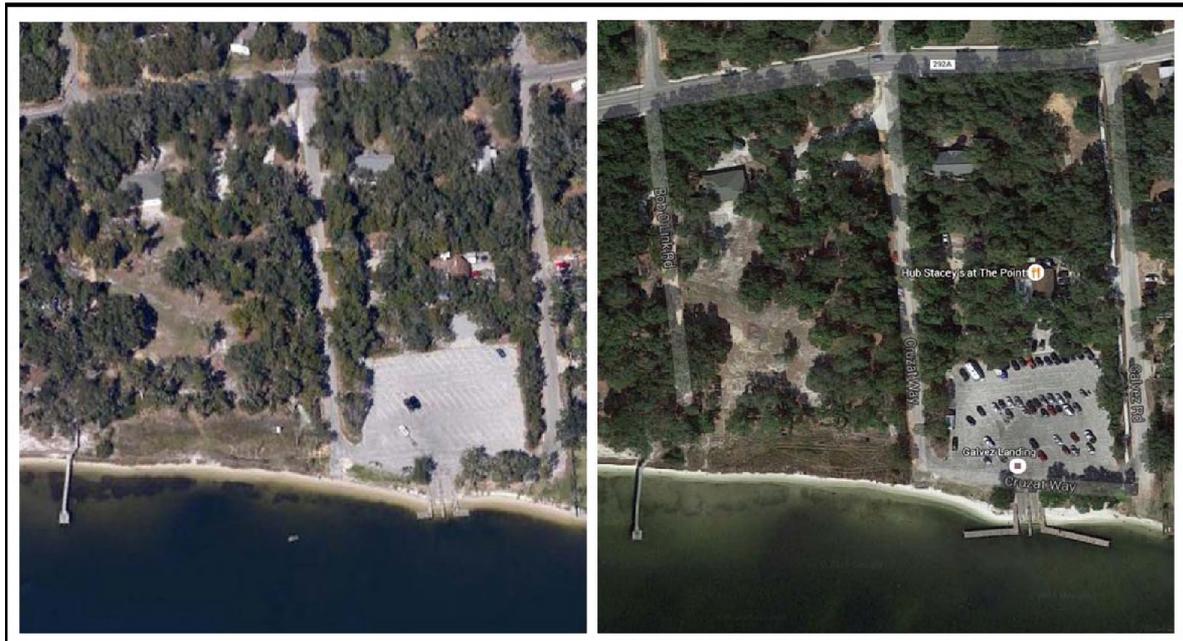
Figure 7: SAV off of the Innerarity parcel in 2012 (left) and 2015 (right). Source: Google Maps 2012, 2015.

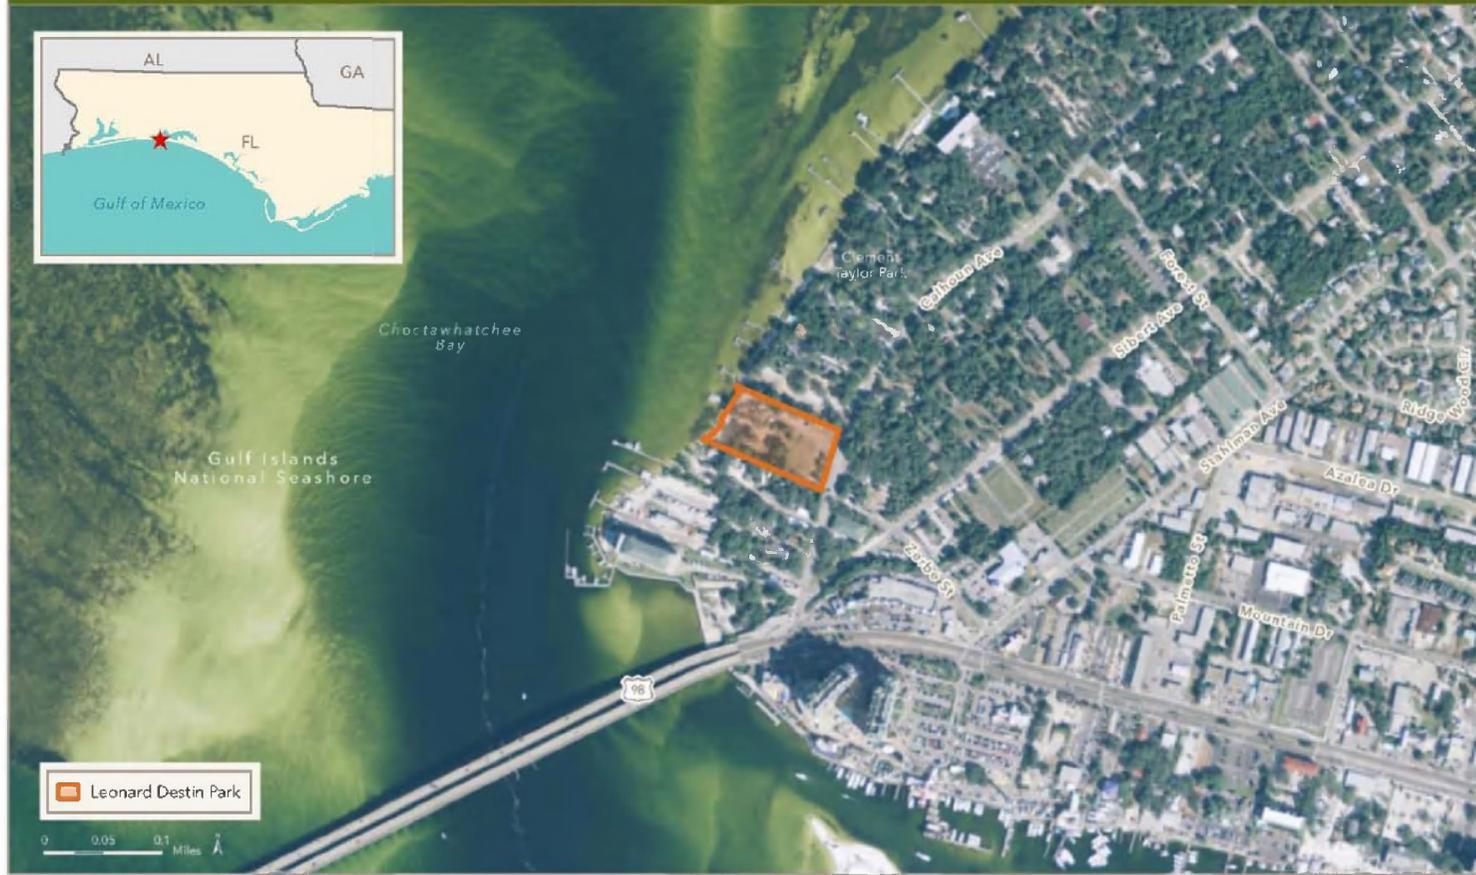
Figure 8: Proposed Leonard Destin Park Plot; 3.38 acre site in Okaloosa County, Florida on Choctawhatchee Bay.

The proposed Florida Coastal Access Project: Leonard Destin Park component lies within Okaloosa County (see Figure 8 for proposed parcel location). The property is approximately 3.42 acres and includes 280 linear feet of frontage on Choctawhatchee Bay, a heavily used waterway for recreational and commercial vessel traffic. There is an existing pier on the property, developed in 1994 (see Figure 10). A private commercial pontoon boat and Jet Ski rental business currently operates on the property. The commercial operation utilizes the existing dock as well as the western portion of the property for a gravel parking lot, boat storage, temporary storage units, picnic tables, and beach chairs. Patrons of the pontoon boat and Jet Ski rental operator use the property for parking, picnicking and lounging on the beach (see Figure 9 and Figure 10).

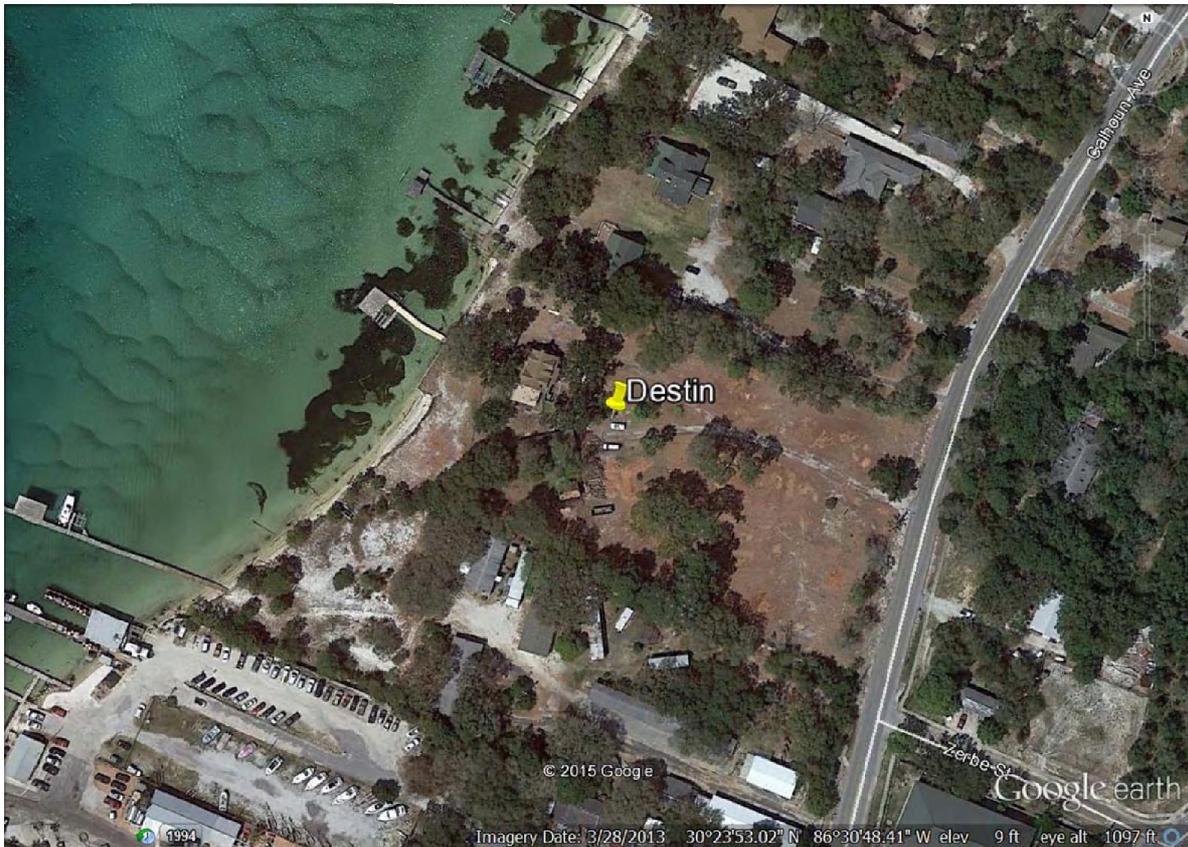
Figure 11: Aerial View of the Proposed Leonard Destin Park Site and Aquatic Habitat. Google Imagery, 2015.

1. **Modified Dock with Kayak Launch.** The existing pier would be modified on the existing pilings by expanding the width to make it ADA compliant. The existing dock has a platform deck at the end of it (see Figure 11). The total area of the dock would be 3,550 square feet. The decking would be comprised of durable composite grated material and the other structural features would be comprised of natural (i.e., wood) material and/or durable composite materials.

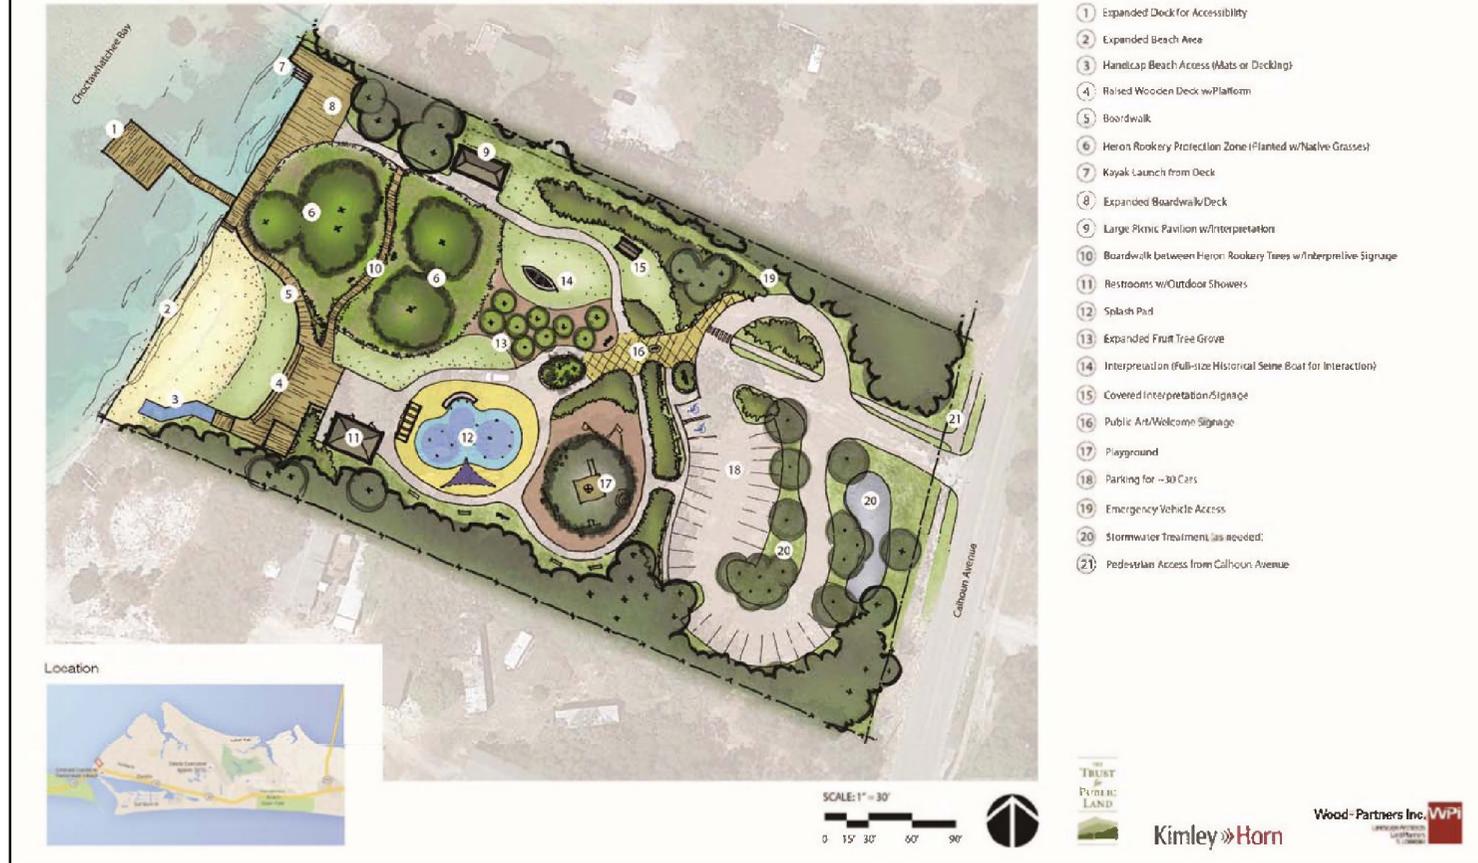
Figure 12: Proposed Leonard Destin Park Conceptual Plan. Left side of the conceptual plan shows the existing dock.

The specific Leonard Destin Park site elements in the proposed conceptual site plan (see Figure 12) include:

8. **Expanded Boardwalk and Deck.** A raised wooden deck would replace existing structures along the shoreline on the north side of the parcel and would be expanded to include 2,725 square feet of water access.

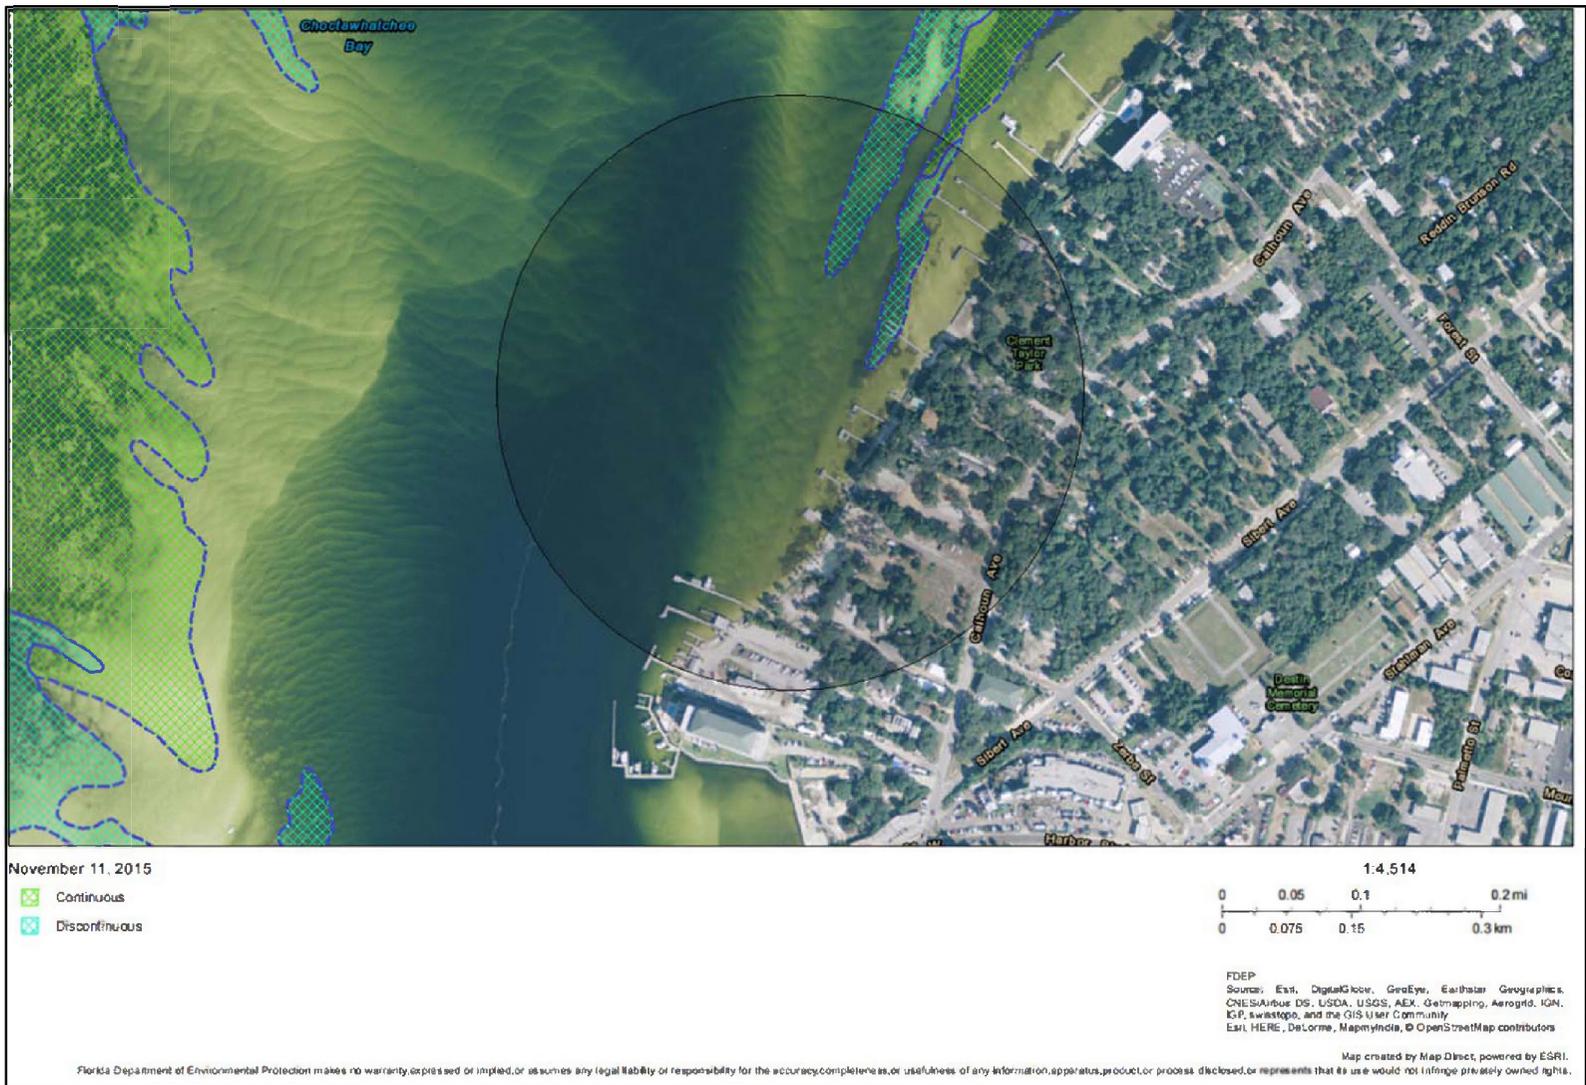
Figure 13: SAV off of the Proposed Leonard Destin Park Parcel (FLDEP 2015).

The proposed Leonard Destin Park is within the EFH area for coastal migratory pelagics, red drum, reef fish, shrimp, and stone crab. SAV, comprised of shoalgrass (*Halodule wrightii*) is present at the Leonard Destin Park project area and based on aerial imagery, there appears to be SAV in the vicinity of the existing dock (FDEP, 2015; see Figure 13 and Figure 14). Updated SAV surveys would occur prior to construction, ideally during June 1 through September 30 because SAV bed continuity, extent, and density are subject to change over time. Mud substrate and estuarine water column habitat also exists within the project area. No HAPC or EFH areas protected from fishing were identified within the project area.

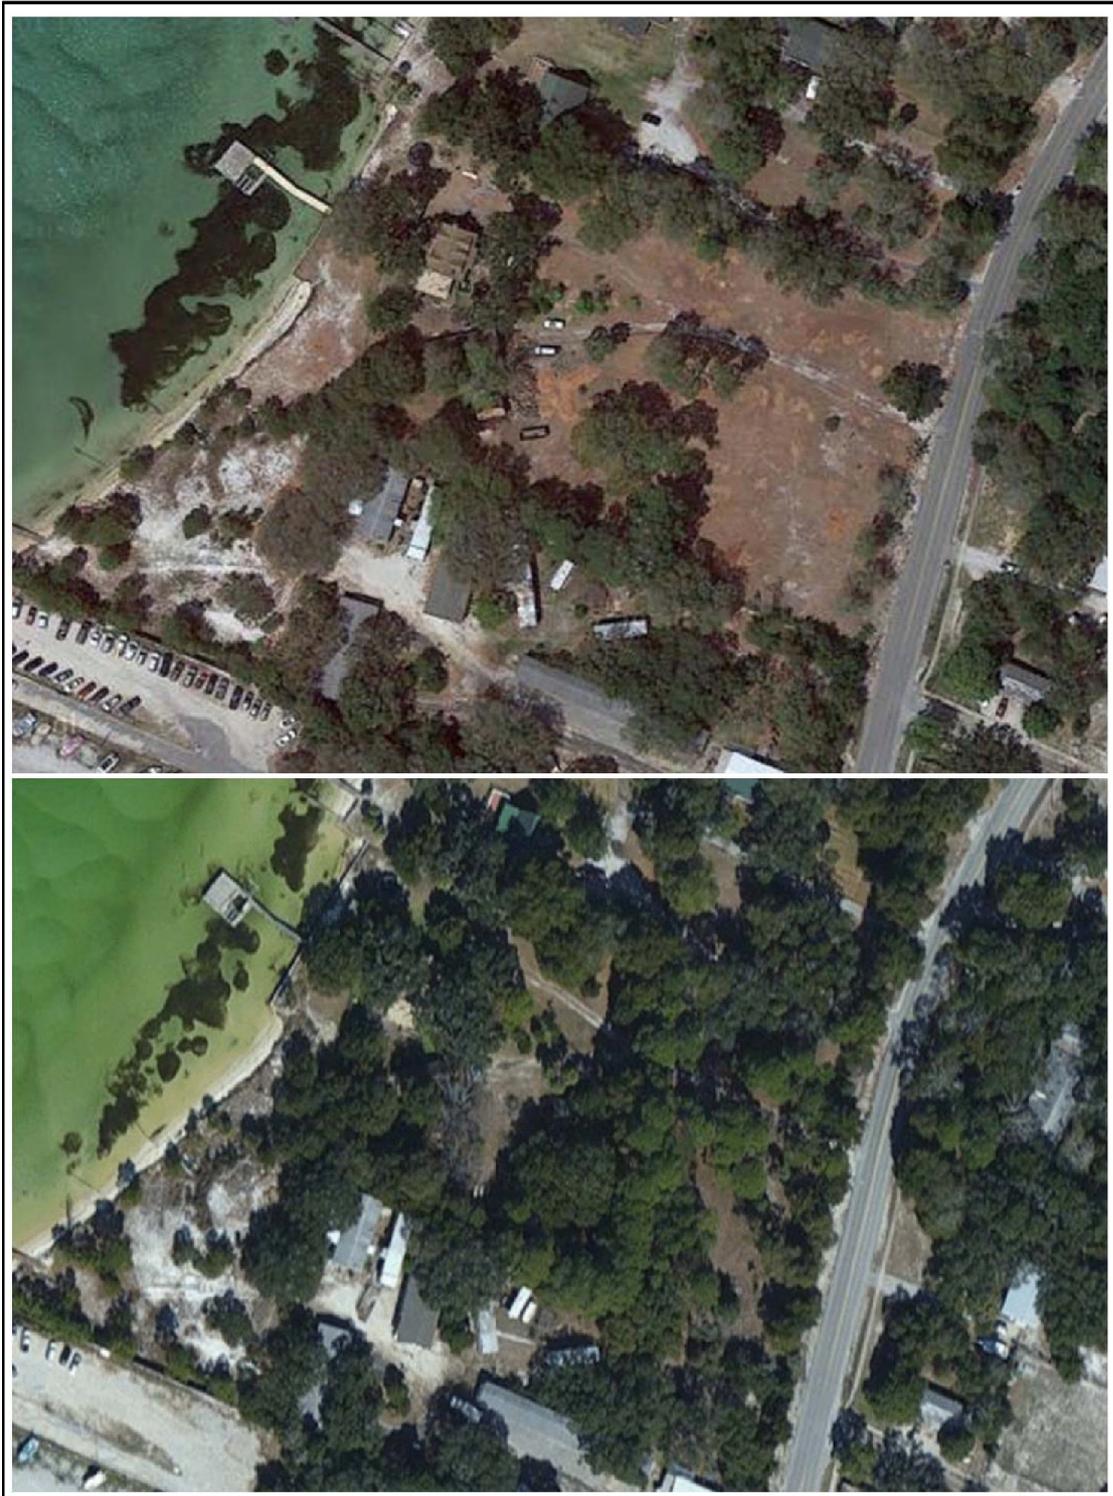
Figure 14: SAV off of the Leonard Destin Park parcel in 2015 (top) and unknown year, likely earlier than 2014 (bottom). Source: Google Maps 2015 and ArcGIS 2015.

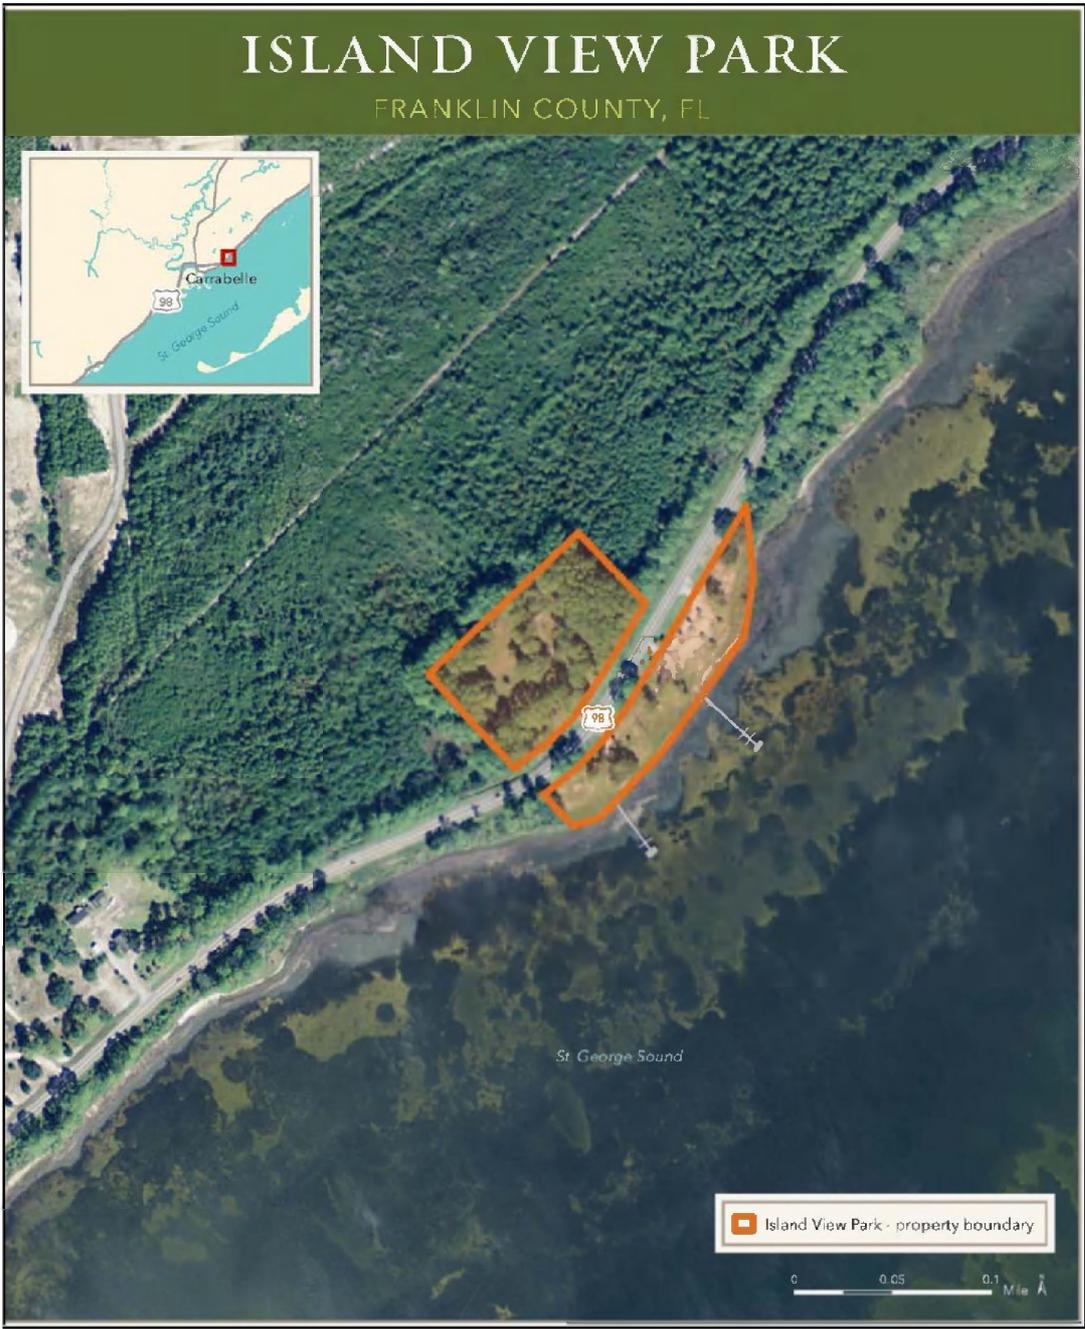
Figure 15: Proposed Island View Park Plot; four acres on the inland parcel and 3.13 acres on the waterfront parcel in Franklin County, Florida on St. George Sound.

The proposed Florida Coastal Access Project: Island View Park component is a 7.13-acre tract of land that is currently owned by and located within Franklin County, Florida about one mile east of the City of Carrabelle¹. The property is divided by U.S. 98, a state-designated Big Bend Scenic Byway, with an inland northwestern parcel (“inland parcel”) that is 4 acres and a southeastern waterfront parcel (“waterfront parcel”) that is 3.13 acres (see Figure 15 and Figure 18 for proposed parcel location). The waterfront parcel of the property includes 884 linear feet of frontage along St. George Sound, which lies between two State-designated aquatic preserves (listed as “Outstanding Florida Waters”) and is adjacent to the Apalachicola National Estuarine Research Reserve. There are two existing piers on the property (see Figure 17). The waterfront parcel was previously developed with number of small cottages as part of a motel. All cottage structures and surface improvements were razed and most debris removed after 2011, other than two fishing docks and a dilapidated concrete boat ramp. There is also a footpath along the waterfront that is bare of vegetation. There are no currently existing barriers to entering the waterfront property, which is used for unofficial parking associated with fishing activities on the existing docks (see Figure 16 and Figure 17). The waterfront parcel has some nearshore grass and some remnant maritime hammock habitat, but much of the waterfront parcel is currently un-vegetated due to prior and ongoing disturbances (see Figure 16 and Figure 17). At the shoreline, emergent marsh grasses occur but have been disturbed by regular mowing. There is SAV present near the piers at this site.

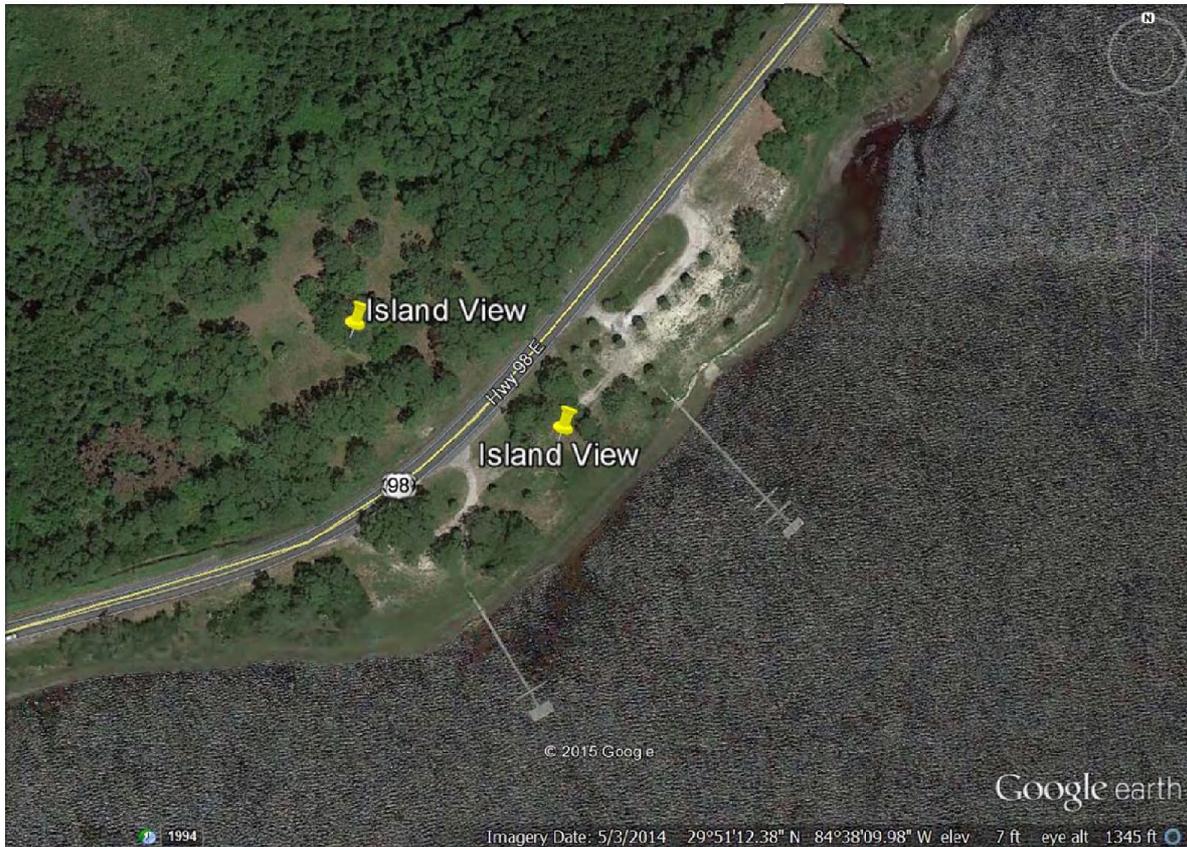
Figure 18: Aerial View of the Proposed Island View Park Site. Google Imagery, 2015.

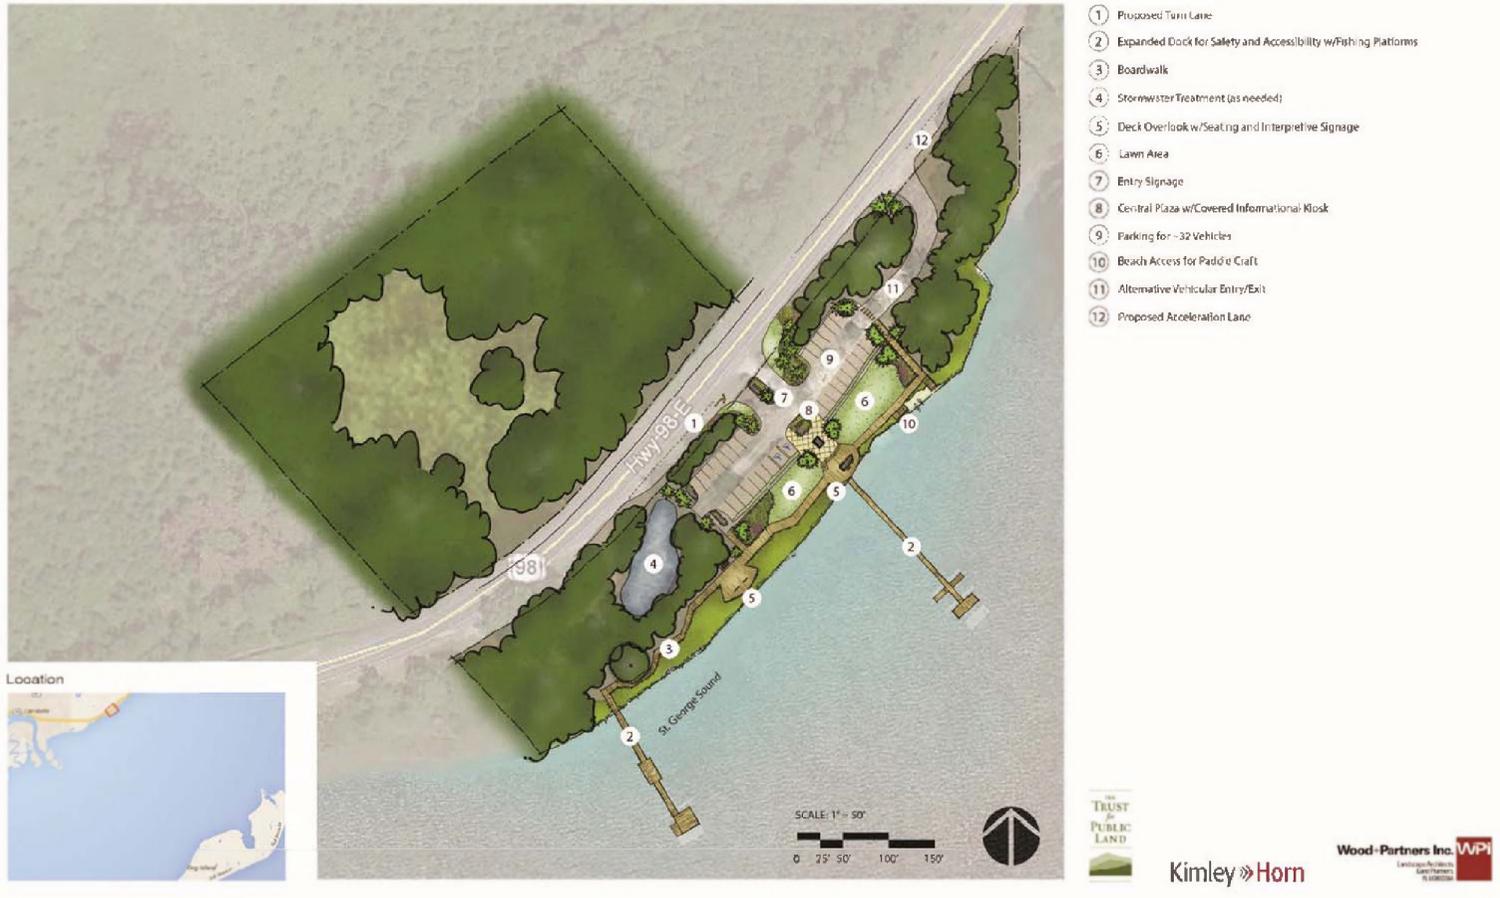
Figure 19: Proposed Island View Park Conceptual Plan. Bottom right of the conceptual plan shows the existing docks.

The specific site elements detailed in the proposed conceptual site plan for the Island View Park parcel (Figure 19) include:

2. **Expanded Dock for Safety and Accessibility with Fishing Platforms.** Dock expansion includes widening the decking to be ADA compliant. All pier work is proposed to be constructed using the existing pilings. The existing planks on the piers would be removed and replaced to create a pier approximately six feet wide with railings. The total square footage of Dock 1 and Dock 2 would be approximately 2,140 square feet and 1,400 square feet, respectively. The design of the expanded dock would incorporate the use of durable composite grated material for the decking.

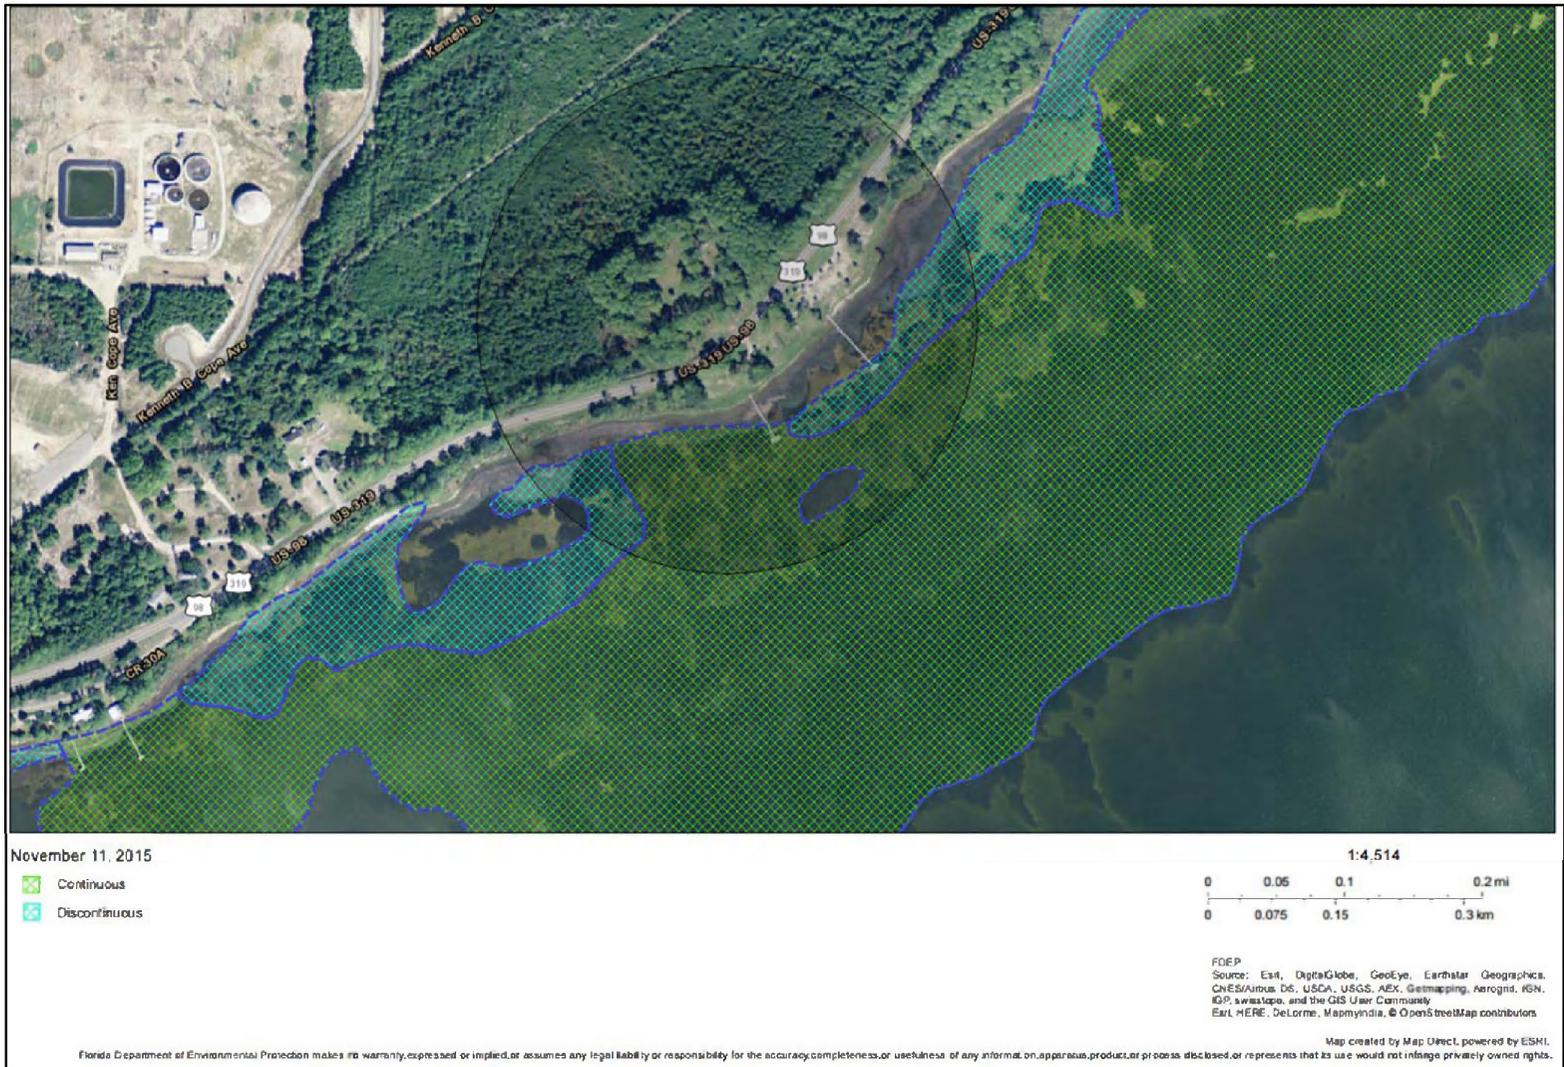
Figure 20: SAV off of the Proposed Island View Park Parcel (FLDEP 2015).
